# **INDOOR AIR QUALITY ASSESSMENT**

**Roosevelt Avenue School  
108 Roosevelt Avenue  
North Attleborough, Massachusetts**

Prepared by:  
Massachusetts Department of Public Health  
Center for Environmental Health  
Bureau of Environmental Health Assessment  
Emergency Response/Indoor Air Quality Program  
December 2004

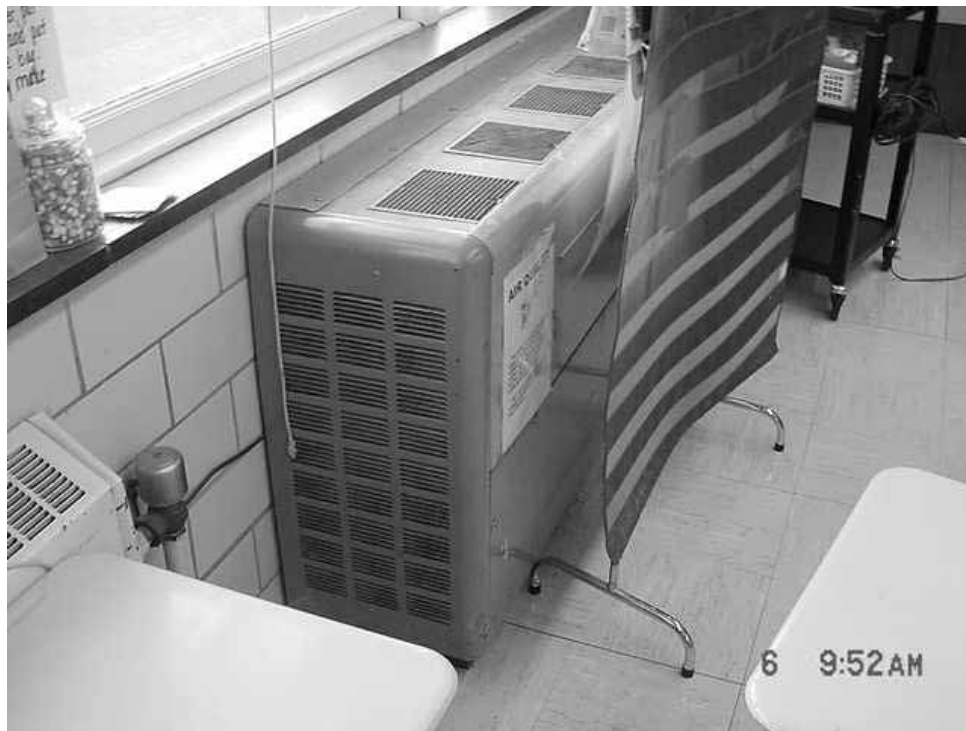
**Picture 1**

It can be seen from Table 1 that carbon dioxide levels were above 800 parts per million (ppm) parts of air in four of twenty areas surveyed, indicating adequate air exchange in the majority of areas surveyed. Fresh air in classrooms is supplied by a unit ventilator (univent) system (Pictures 1 and 2). Univents are designed to draw air from outdoors through a fresh air intake located on the exterior walls of the building (Picture 3) and return air through an air intake located at the base or sides of each unit ([Figure 1/Picture 1](#)). Fresh and return air are mixed and filtered, then heated and provided to classrooms through an air diffuser located in the top of the unit. Univents have manual fan controls of low, medium and high to adjust fan speed (Picture 4). Obstructions to airflow, such as papers and books stored on univents and bookcases, carts and desks in front of univent returns, were seen in a few classrooms. In order for univents to provide fresh air as designed, units must remain free of obstructions.

**1950's Vintage Univent, Note Return Vents on Sides of Univent**

1. Examine each univent for function. Survey classrooms for univent function to ascertain if an adequate air supply exists for each room. Consider consulting a heating, ventilation and air conditioning (HVAC) engineer concerning the calibration of univent fresh air control dampers.

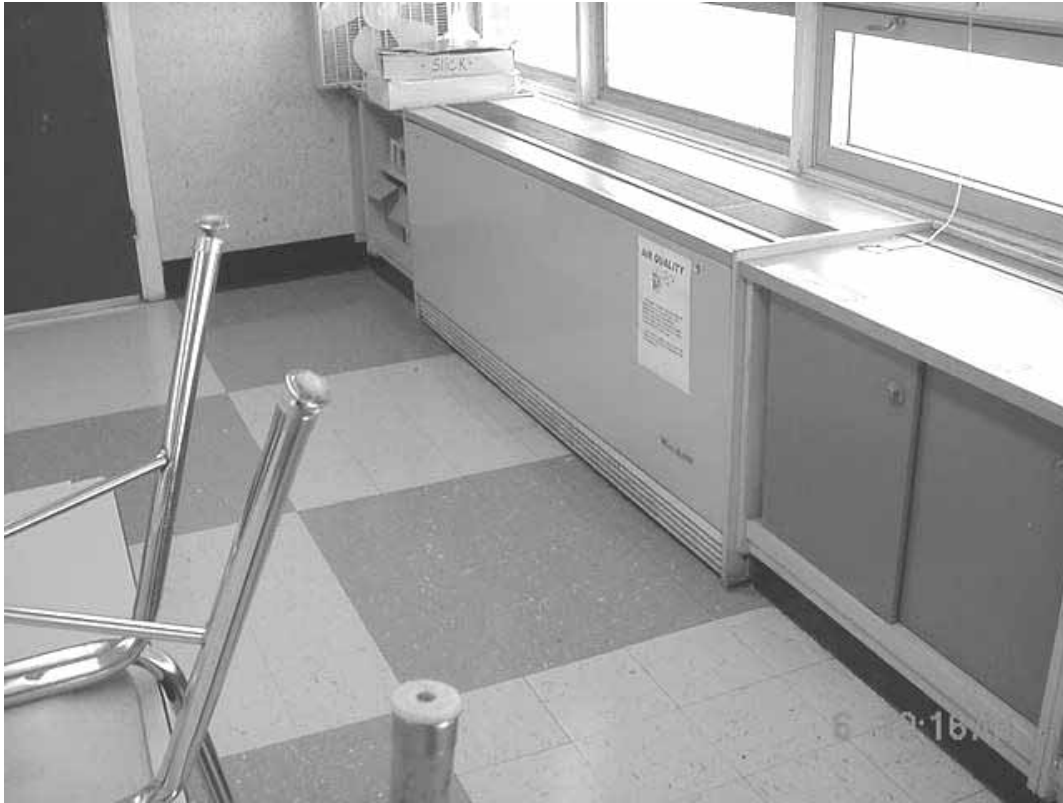
**Picture 2**

**Modern Univent in 1970's Addition**

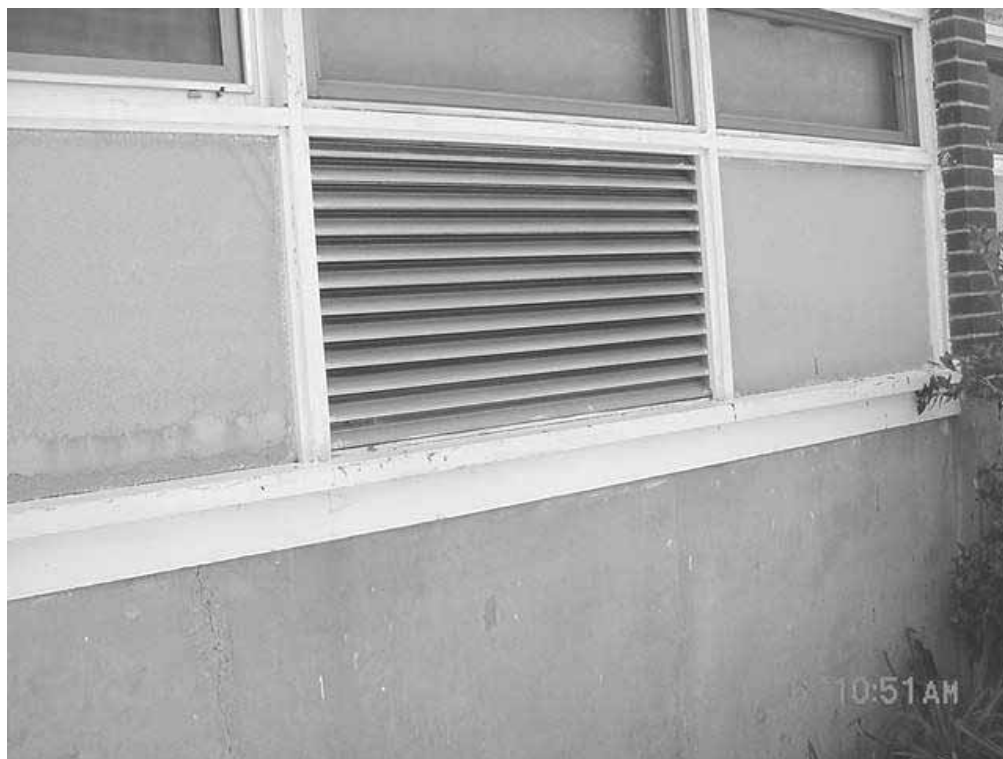
**Picture 3**

**Univent Air Intake**

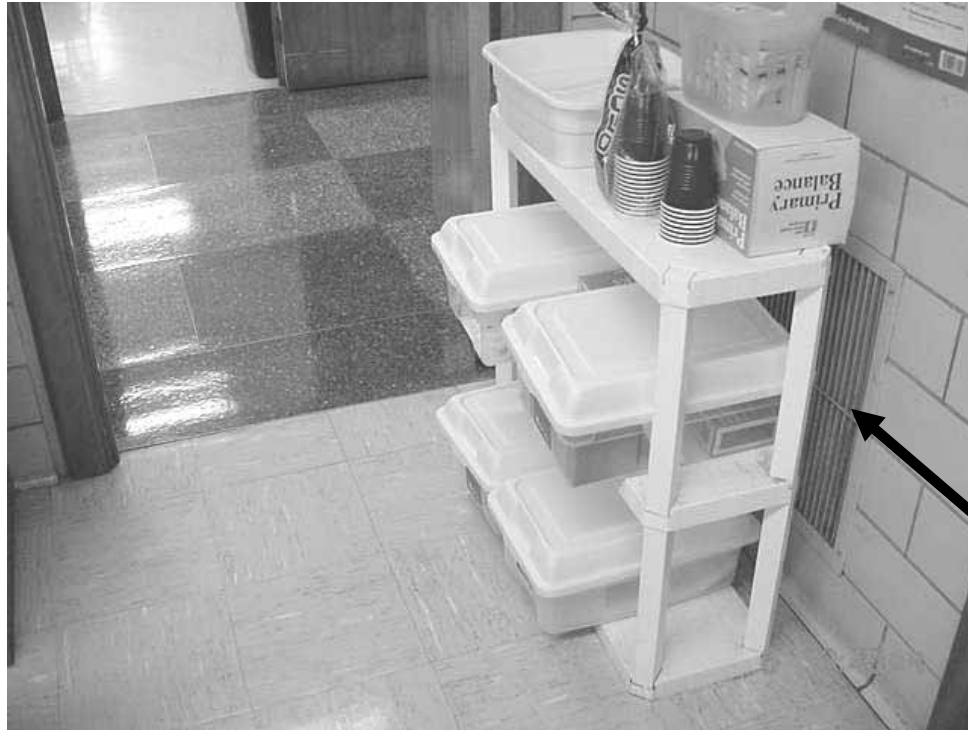
**Picture 5**

Exhaust ventilation in classrooms is provided by ducted, grated wall vents powered by rooftop motors (Pictures 5 to 7). A number of exhaust vents were not operating, indicating that motors were deactivated or non-functional. BEHA staff and Mr. Tibbetts examined exhaust motors on the roof and found several not operating. A number of exhaust vents were also obstructed by desks, bookcases and other items (Picture 5). As with the univents, in order to

function properly, exhaust vents must be activated and remain free of obstructions. In addition, the location of some exhaust vents can limit exhaust efficiency. In the 1970s wing, exhaust vents are located above hallway doors (Picture 6). When classroom doors are open, exhaust vents will tend to draw air from both the hallway and the classroom reducing the effectiveness of the exhaust vent to remove common environmental pollutants.

**Obstructed Exhaust Vent, Note Proximity to Open Hallway Door**

5. Remove all blockages from univents and exhaust vents to ensure adequate airflow.
6. Consider having ventilation systems re-balanced every five years by an HVAC engineering firm.

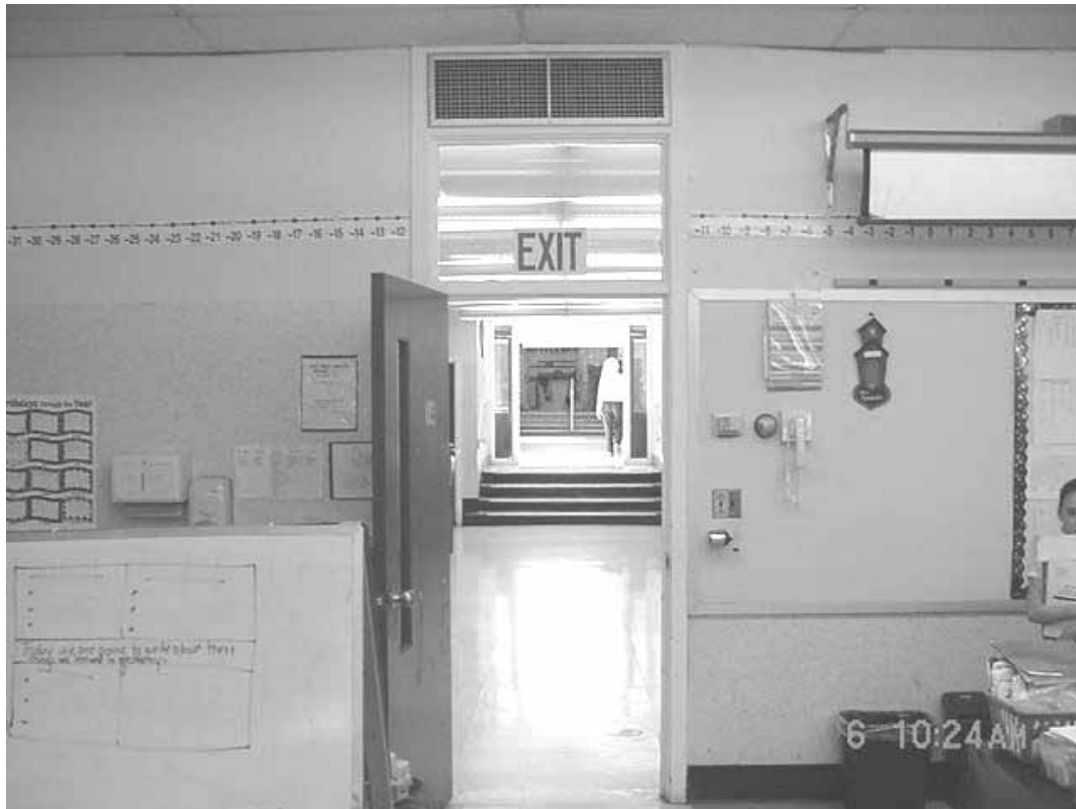
**Picture 6**

**Exhaust Vent in 1970's Addition, Note Open Hallway Door**

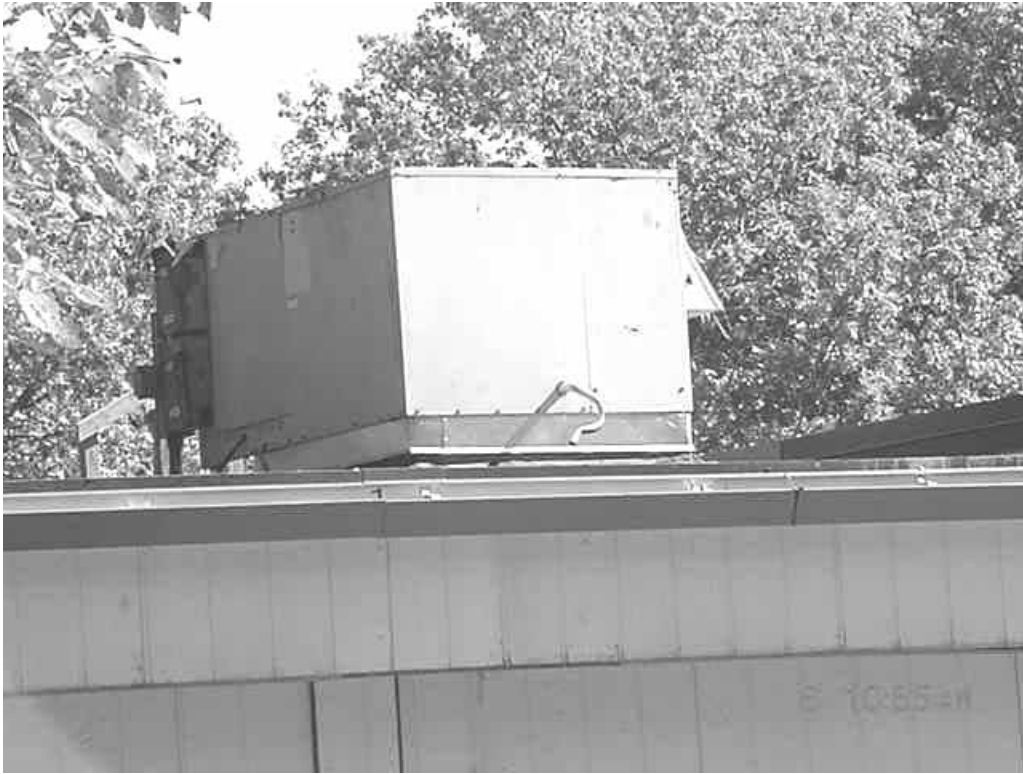
**Picture 9**

Ventilation for modular classrooms is provided by rooftop AHUs (Picture 9). Fresh air is distributed to classrooms via ductwork connected to ceiling-mounted air diffusers and drawn back to the units through ceiling-mounted grilles (Picture 10). Thermostats that control each heating, ventilating and air conditioning (HVAC) system have fan settings of “on” and “automatic”. Thermostats were set to the “automatic” setting (Picture 11) in both of the modular rooms during the assessment. The automatic setting on the thermostat activates the HVAC system at a preset temperature. Once the preset temperature is reached, the HVAC system is deactivated. Therefore, no mechanical ventilation is provided until the thermostat re-activates the system.

**Modular Classroom Rooftop AHU**

3. Set the thermostat for modular classrooms to the fan “on” position to operate the ventilation system continuously during the school day.
4. Inspect exhaust motors and belts for proper function. Repair and replace as necessary.

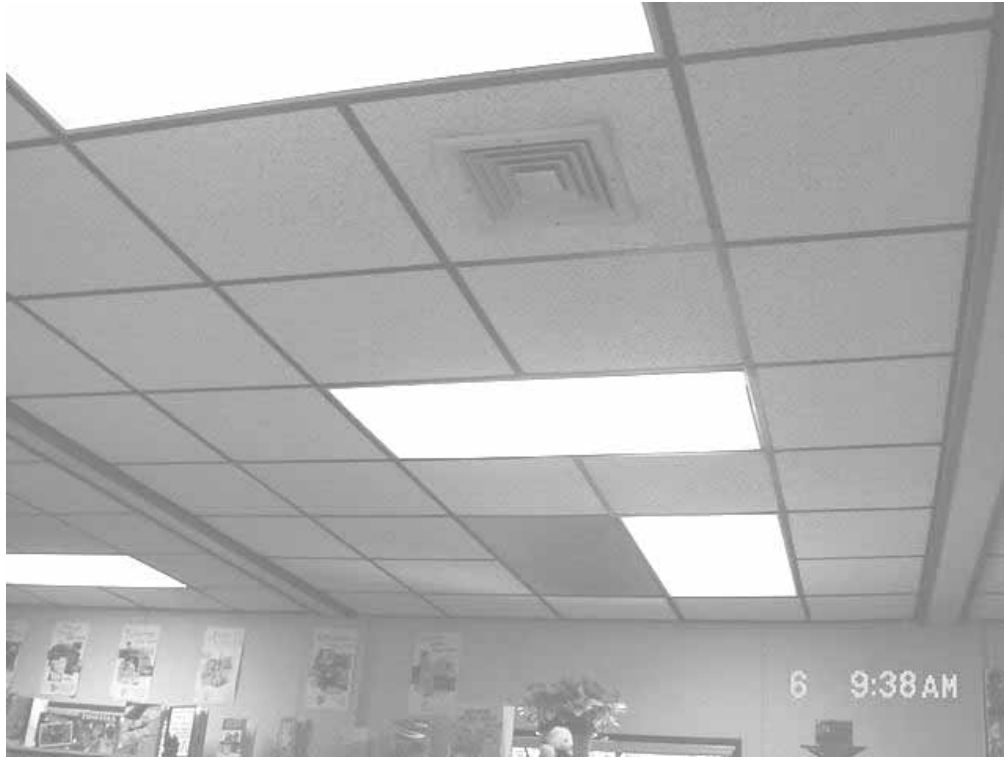
**Picture 10**

**Supply and return Vents in Ceiling of Modular Classroom**

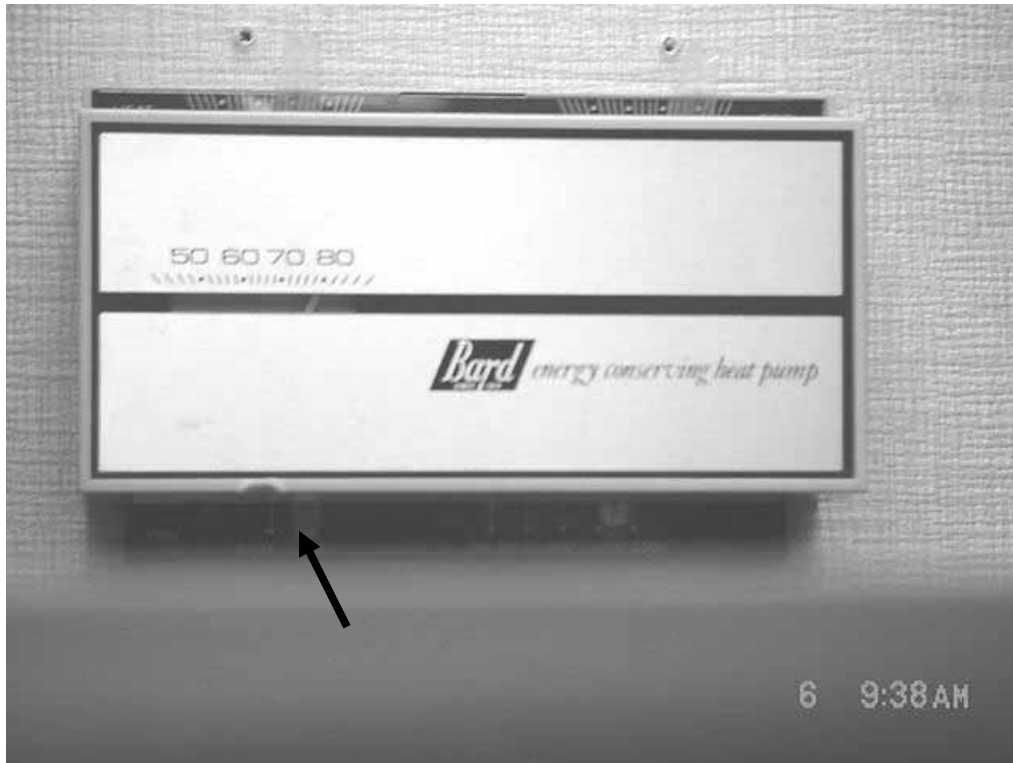
**Picture 11**

**Thermostat for Modular Classroom AHU, Fan Switch Set to “Auto” (Bottom Left)**

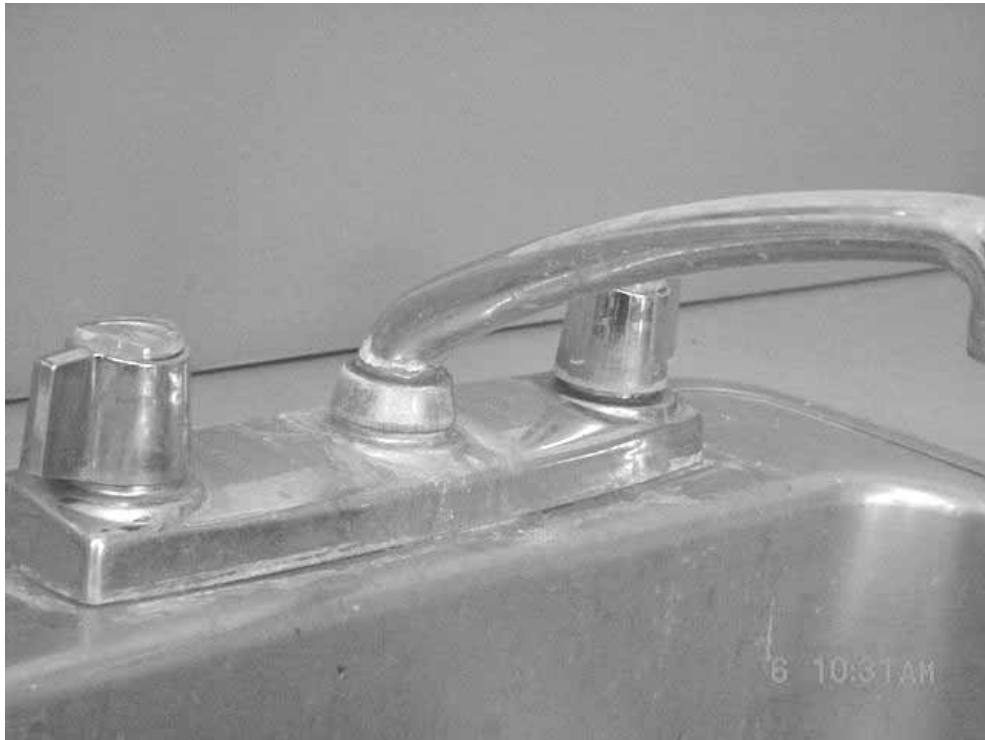
**Picture 12**

Spaces between the sink countertop and backsplash were noted in several classrooms (Table 1/Picture 12). Improper drainage or sink overflow can lead to water penetration of countertop wood, the cabinet interior and areas behind cabinets. A leaking faucet was observed

beneath the cabinet in classroom 11. Like other porous materials, if these materials become wet repeatedly they can provide a medium for mold growth.

**Breach between Sink Countertop and Backsplash**

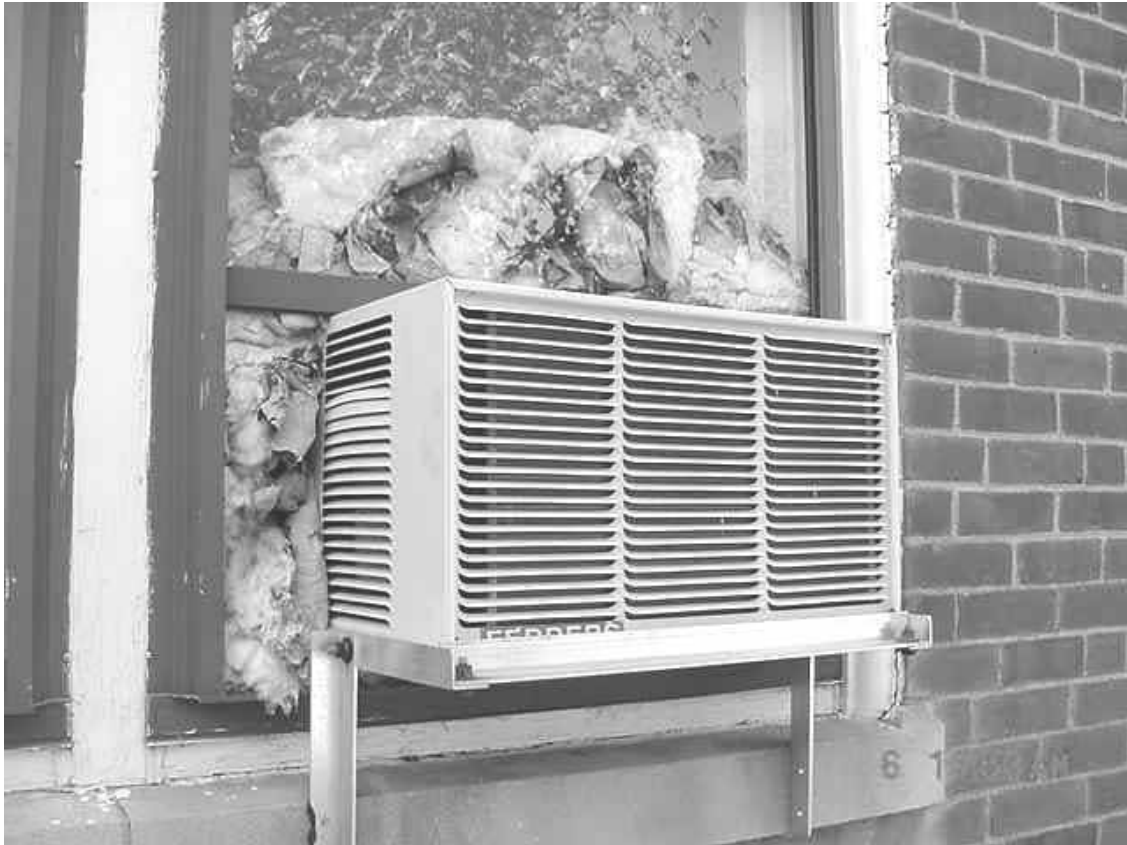
**Picture 13**

Fiberglass insulation was observed to be used around window-mounted air conditioners to block drafts. In several areas, the insulation was exposed to moisture on the exterior of the building (Picture 13). The US Environmental Protection Agency (US EPA) and the American Conference of Governmental Industrial Hygienists (ACGIH) recommends that porous materials be dried with fans and heating within 24 to 48 hours of becoming wet (US EPA, 2001; ACGIH, 1989). If porous materials are not dried within this time frame, mold growth may occur. Water-damaged porous materials cannot be adequately cleaned to remove mold growth. The application of a mildewcide to moldy porous materials is not recommended.

**Exposed Fiberglass Insulation around Window-Mounted Air Conditioner**

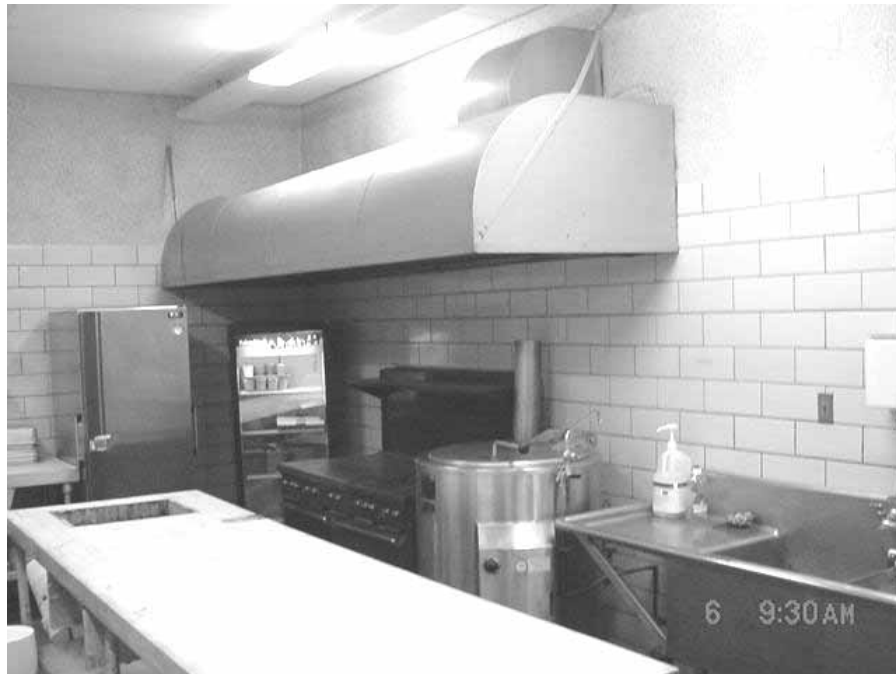
**Picture 14**

monoxide concentrations were non-detect or ND (Table 1). Carbon monoxide levels measured in the school were also ND. Although no carbon monoxide was detected in the school, BEHA staff noted a slight natural gas odor upon entering the cafeteria. The source of the odor was a gas stove in the kitchen (Picture 14). The vent hood above the stove is not motorized and was found backdrafting during the assessment. Backdrafting can pressurize the kitchen and distribute gas odors and combustion products into adjacent areas.

**Non-Motorized Vent Hood above Gas Stove in Kitchen**

7. Consider installing mechanical exhaust ventilation in the kitchen and copy room to remove excess heat, combustion products and pollutants.
8. For buildings in New England, periods of low relative humidity during the winter are often unavoidable. Therefore, scrupulous cleaning practices should be adopted to minimize common indoor air contaminants whose irritant effects can be enhanced when the relative humidity is low. To control for dusts, a high efficiency particulate arrestance (HEPA) filter equipped vacuum cleaner in conjunction with wet wiping of all surfaces is recommended. Avoid the use of feather dusters. Drinking water during the day can help ease some symptoms associated with a dry environment (throat and sinus irritations).

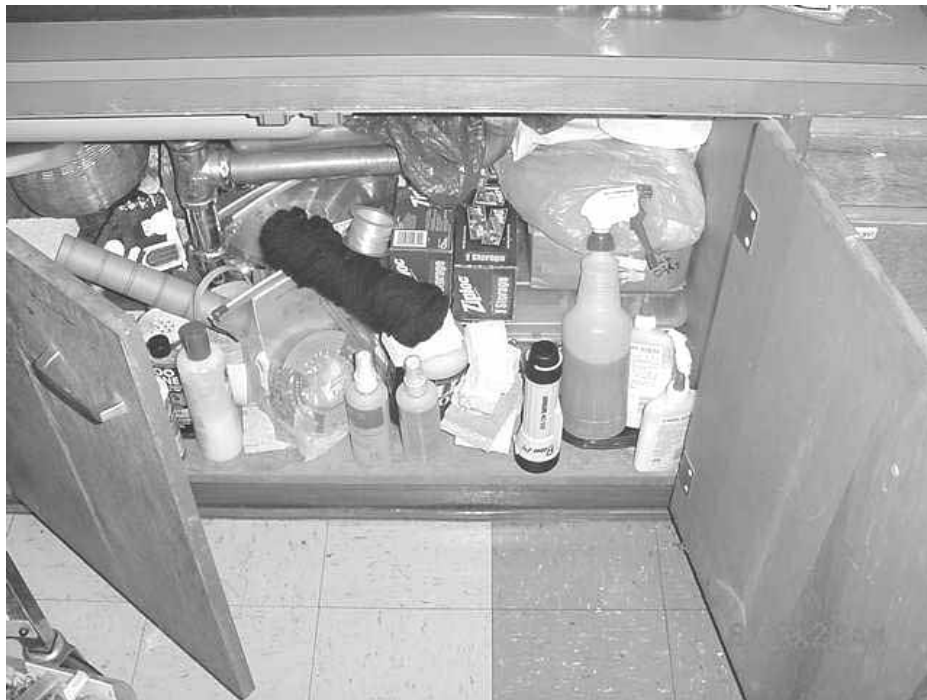
**Picture 15**

Please note, TVOC air measurements are only reflective of the indoor air concentrations present at the time of sampling. Indoor air concentrations can be greatly impacted by the use of TVOC containing products. While no measurable TVOC levels were detected in the indoor environment, VOC-containing materials were noted. Cleaning products were found on countertops and beneath sinks in a number of classrooms (Picture 15). Cleaning products contain VOCs and other chemicals that can be irritating to the eyes, nose and throat and should be stored properly and kept out of reach of students.

**Cleaning “Spray” Products under Sink Cabinet in Classroom**

13. Store cleaning products properly and out of reach of students.
14. Consider discontinuing the use of tennis balls on chairs to prevent latex dust generation.

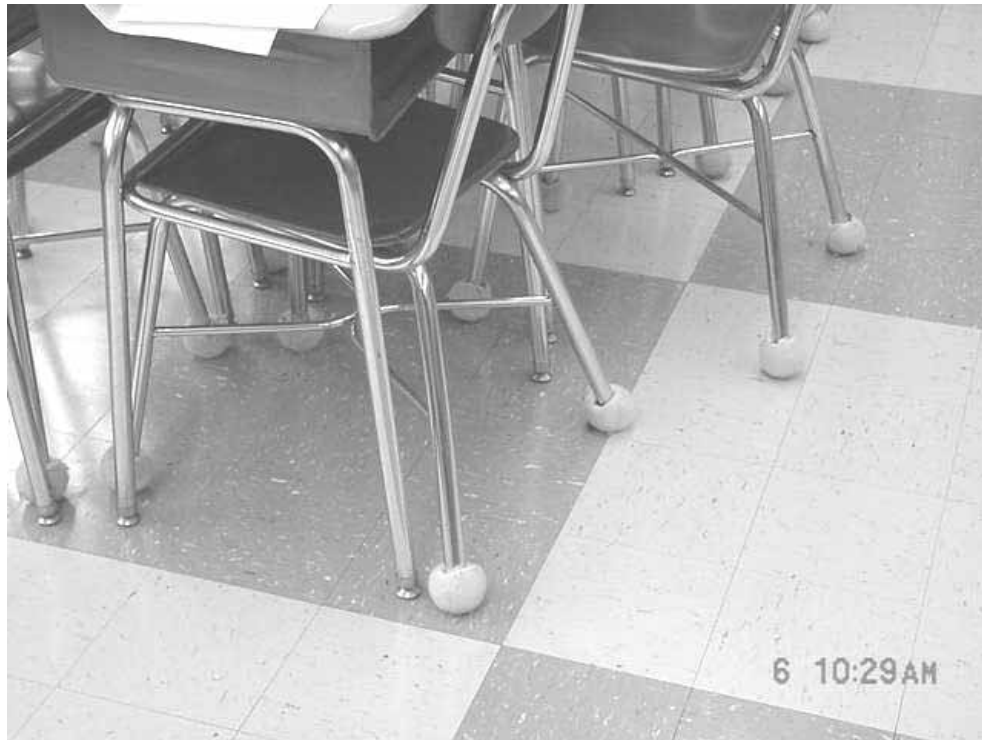
**Picture 16**

In an effort to reduce noise from sliding chairs, tennis balls had been sliced open and placed on chair legs (Picture 16). Tennis balls are made of a number of materials that are a source of respiratory irritants. Constant wearing of tennis balls can produce fibers and cause TVOCs to off-gas. Tennis balls are made with a natural rubber latex bladder, which becomes abraded when used as a chair leg pad. Use of tennis balls in this manner may introduce latex dust into the school environment. Some individuals are highly allergic to latex (e.g., spina bifida patients) (SBAA, 2001). It is recommended that the use of materials containing latex be limited in buildings to reduce the likelihood of symptoms in sensitive individuals (NIOSH, 1997). A question and answer sheet concerning latex allergy is attached as [Appendix B](#) (NIOSH, 1998).

**Tennis Balls on Chair Legs in Classroom**
